## YRC1000 ALARM CODES (MAJOR ALARMS)

### MOTOMAN INSTRUCTIONS

MOTOMAN-□□□ INSTRUCTIONS  
YRC1000 INSTRUCTIONS  
YRC1000 OPERATOR'S MANUAL (GENERAL) (SUBJECT SPECIFIC)  
YRC1000 MAINTENANCE MANUAL  
YRC1000 ALARM CODES (MAJOR ALARMS) (MINOR ALARMS)

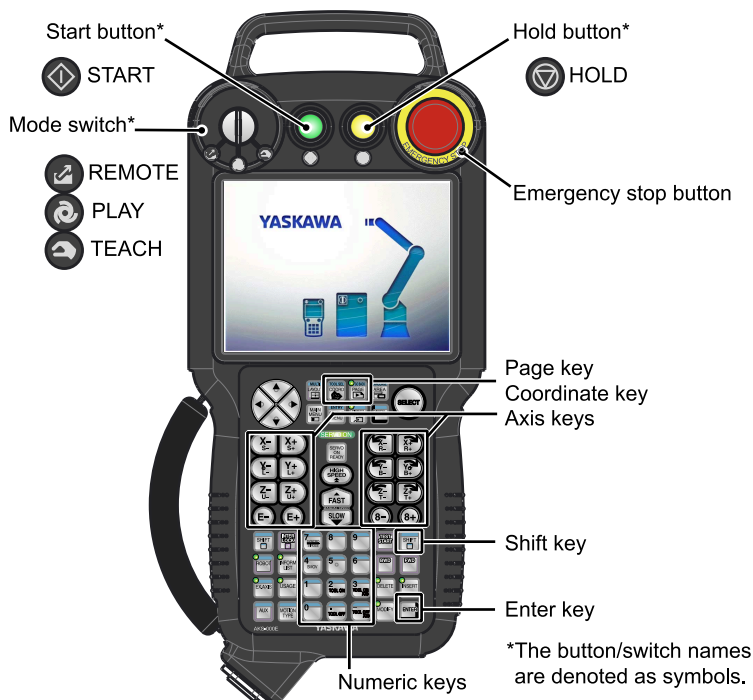
| Equipment | Manual Designation |
|---|---|
| | Button<br>The three buttons on the upper side of the programming pendant are denoted as follows: START, HOLD, or EMERGENCY STOP.<br>(The button names are denoted as symbols) |
| | Displays<br>The menu displayed in the programming pendant is denoted with { }.<br>e.g. {JOB} |
